## Product Notice

**Summary of issue: Dual-action pull station activation handle**

**Model numbers: All dual-action type pull stations**

**Manufactured date range: July 2007 to January 2010 [date codes 7071 to 0011]**

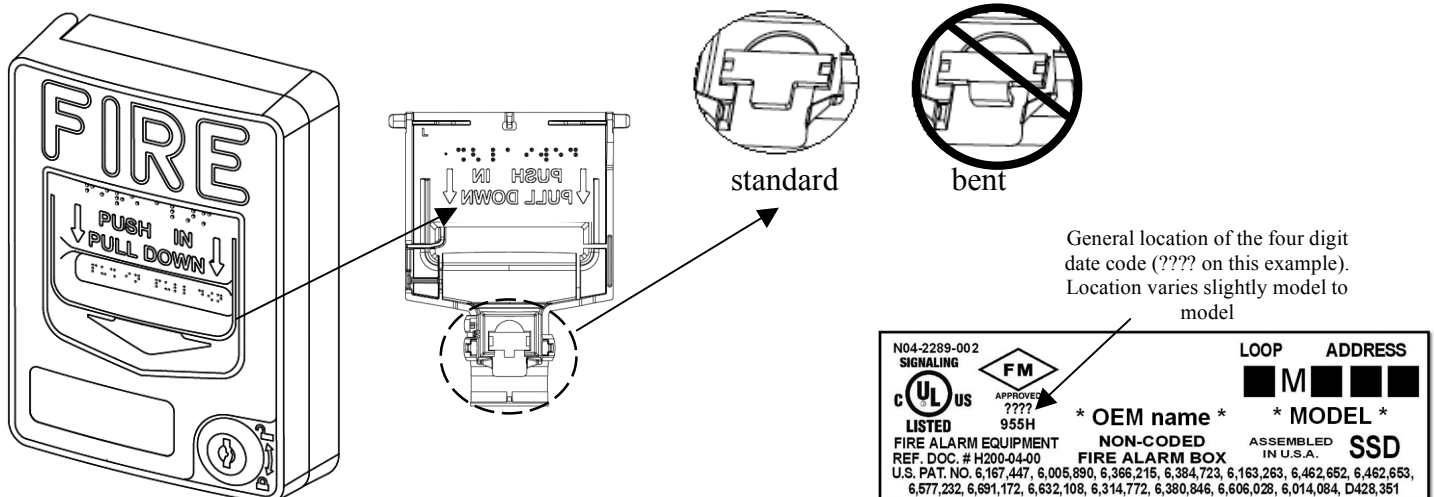
System Sensor has been made aware of the potential for an issue with certain pull stations that were manufactured at our St. Charles, Illinois facility between July 2007 and January 2010. The affected models are of the “dual-action” type. These are clearly identified by the marking on the activation handle which reads “Push In - Pull Down” as shown in the drawing below. Single action pull stations, marked “Pull Down” only, are not affected.

The activation handle on these models made use of a molded-in tab that creates the need to push the handle in before pressing downward. Some customers have reported to us that the tab can become bent in such a fashion as to inhibit movement of the handle and inhibit activation. After review and investigation, it appears that the bent tab is the result of improper installation/operation and should be apparent during normal testing and inspection per NFPA. The incident rate is extremely low and does not appear to be tied to any specific material lot or environmental condition. A design change was made to the handle component in January of 2010 that eliminated this issue.

As a part of your annual inspections and system commissioning, inspection and testing of each pull station must be conducted in the manner in which it was designed to operate and as described in the installation manual: push in and pull down on the handle. As stated in Table 14.4.2.2, section 14 (e), of the 2010 edition of NFPA 72®: “Manual fire alarm boxes shall be operated per the manufacturer’s published instructions.” This manner is consistent with operation by a typical building occupant. The pull station must not be tested in a fashion outside of the operational design. Opening the door of the pull station and manually activating the alarm switch does not meet the intent of NFPA described above. If the pull station is not tested in the proper manner, a bent tab could be overlooked.

If the pull station actuates normally and a visual inspection of the tab shows it to be straight, then the pull station does not have this issue. System Sensor will, free of charge, replace under normal warranty terms any pull station exhibiting the condition described and manufactured with a date code range of 7071 through 0011.
